Cleaning and greasing of Olympus U-TRSW trinocular

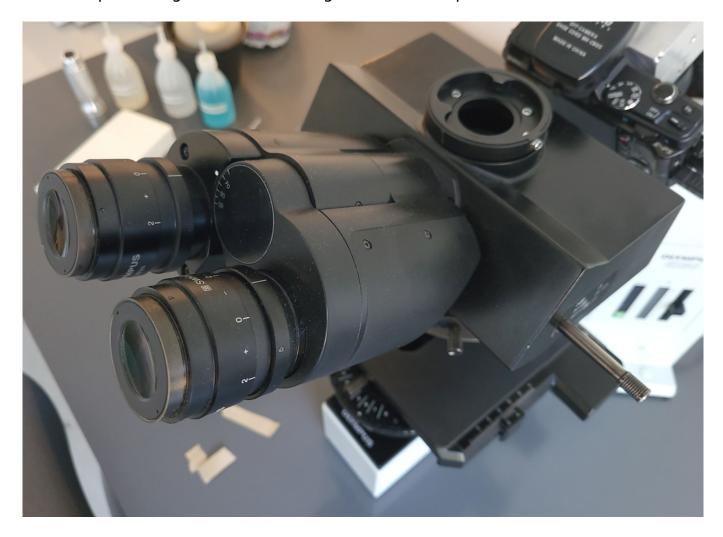
My Olympus U-TRSW super widefield trinocular (s. fig. 1) is in constant use, as I do a lot of photography and therefore often use the slider for the beam splitter. Due to the frequent use, it becomes increasingly difficult to operate the lateral push rod and dust particles get into the housing and the beam path over time.

Fig. 1: The Olympus super widefield trinocular tubus U-TRSW.

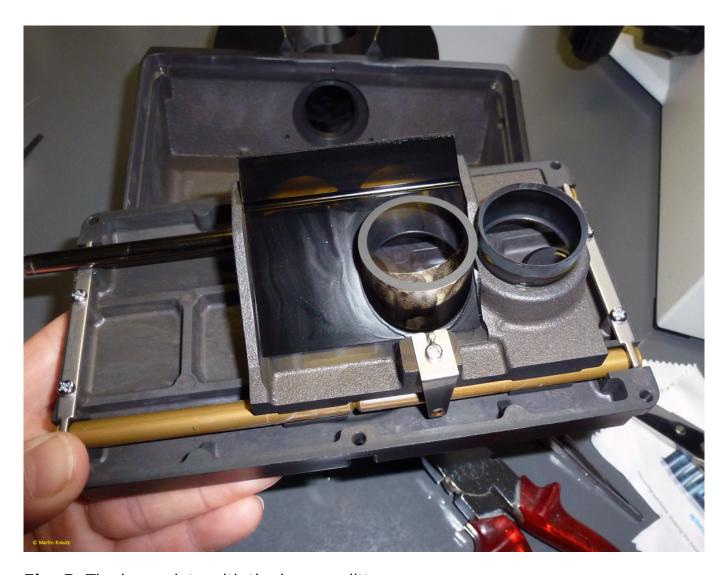
Fig. 5: The base plate with the beam splitter.

The base plate with the beam splitters attached to it can now be very carefully removed from the tube housing. The base plate is fitted very precisely. You have to be very careful and should not allow the half-removed base plate to fall back into place. The base plate and optics can then be lifted out of the housing in one piece (s. fig. 5).

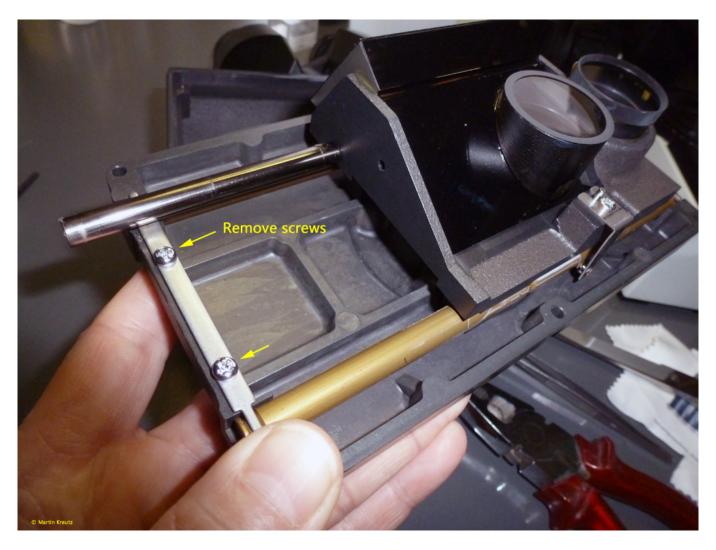
Fig. 6: Remove the screws of the fixing bracket on the left side.

The yellow anodized slide rails on which the beam splitter moves can be seen clearly. These must be taken out in order to completely remove the old grease. To do this, loosen the 4 screws with which two fixing brackets are screwed onto the base plate (s. fig. 6 and 7).

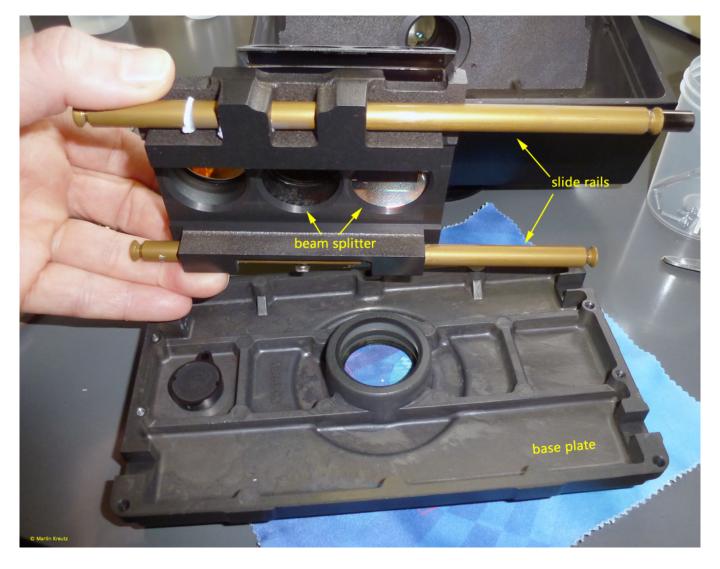
Fig. 8: The detached beam splitter from the base plate.

Now the beam splitter together with the slide rails can be detached from the base plate (s. fig. 8).

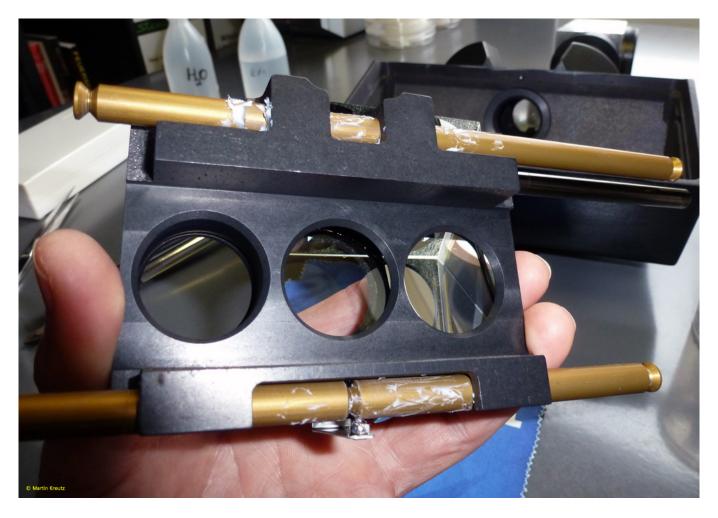
Fig. 9: The slide rails with new grease.

After removing it from the base plate, I thoroughly degreased the slide rails with isopropanol and then applied new grease with a toothpick (s. fig. 9). I used a perfluoropolyethers grease (PFPE) for the slide rails.

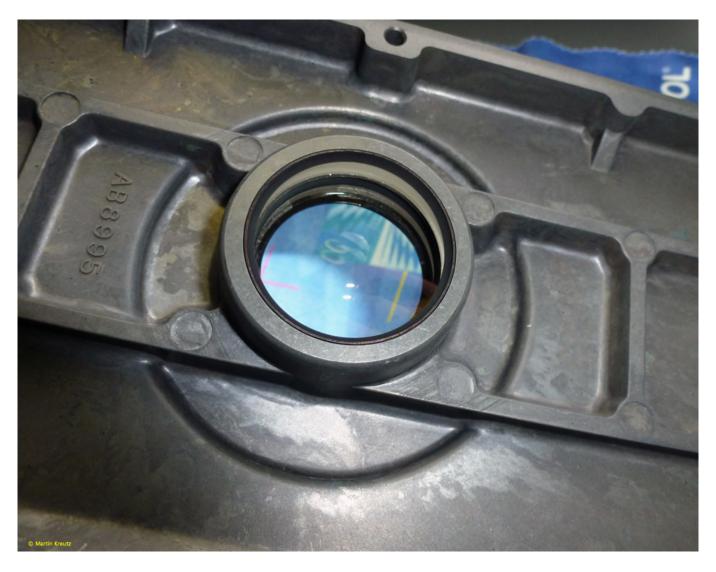
Fig. 10: The lens embedded in the base plate after cleaning with glass cleaner.

A lens is embedded in the base plate, which I cleaned with a microfiber cloth and some glass cleaner (s. fig. 10).
