**Cleaning and greasing of Olympus U-TRSW trinocular**

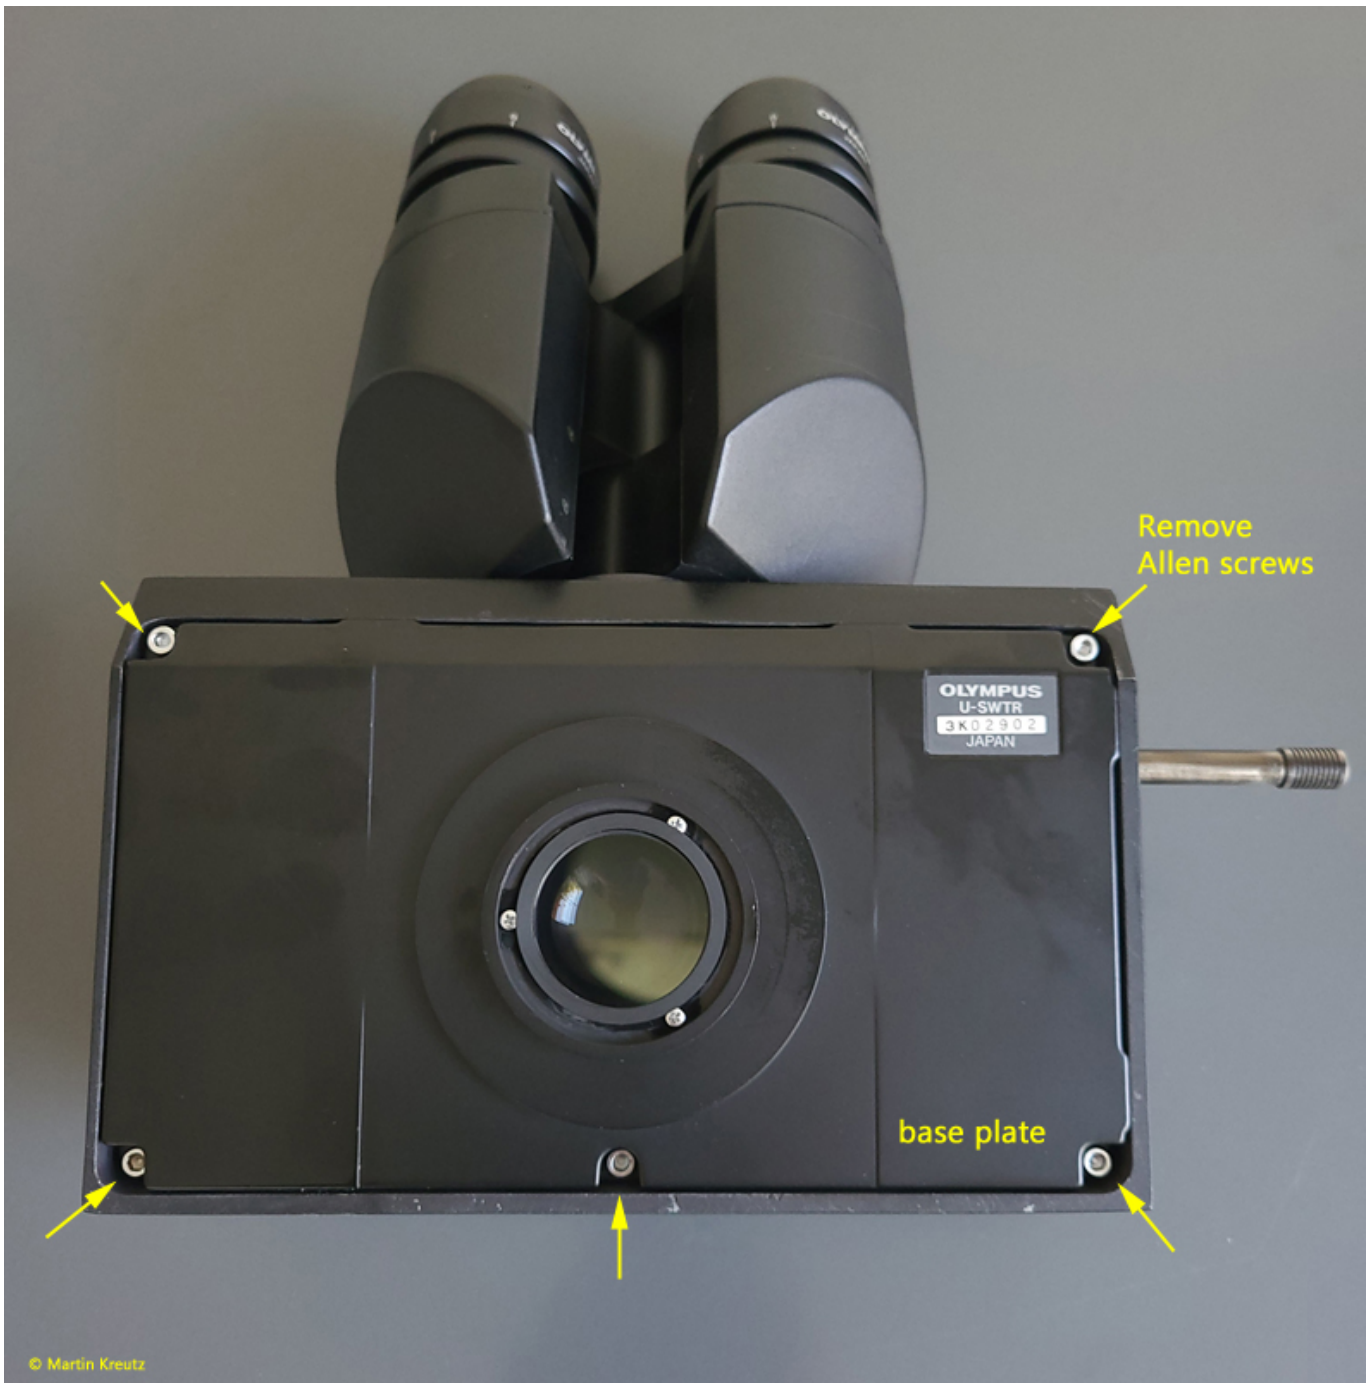
**Fig. 2:** The 5 Allen screws (arrows) has to be removed.

I therefore clean the trinocular tube every 10–15 years. To disassemble it, the trinocular has to be place carefully on the table with the base plate facing upwards (s. fig. 2). Care must be taken to ensure that the eyepieces do not accidentally fall out, but I always leave them in to avoid any dust ingress. First, the 5 Allen screws of the base plate must be loosened (s. fig 2).

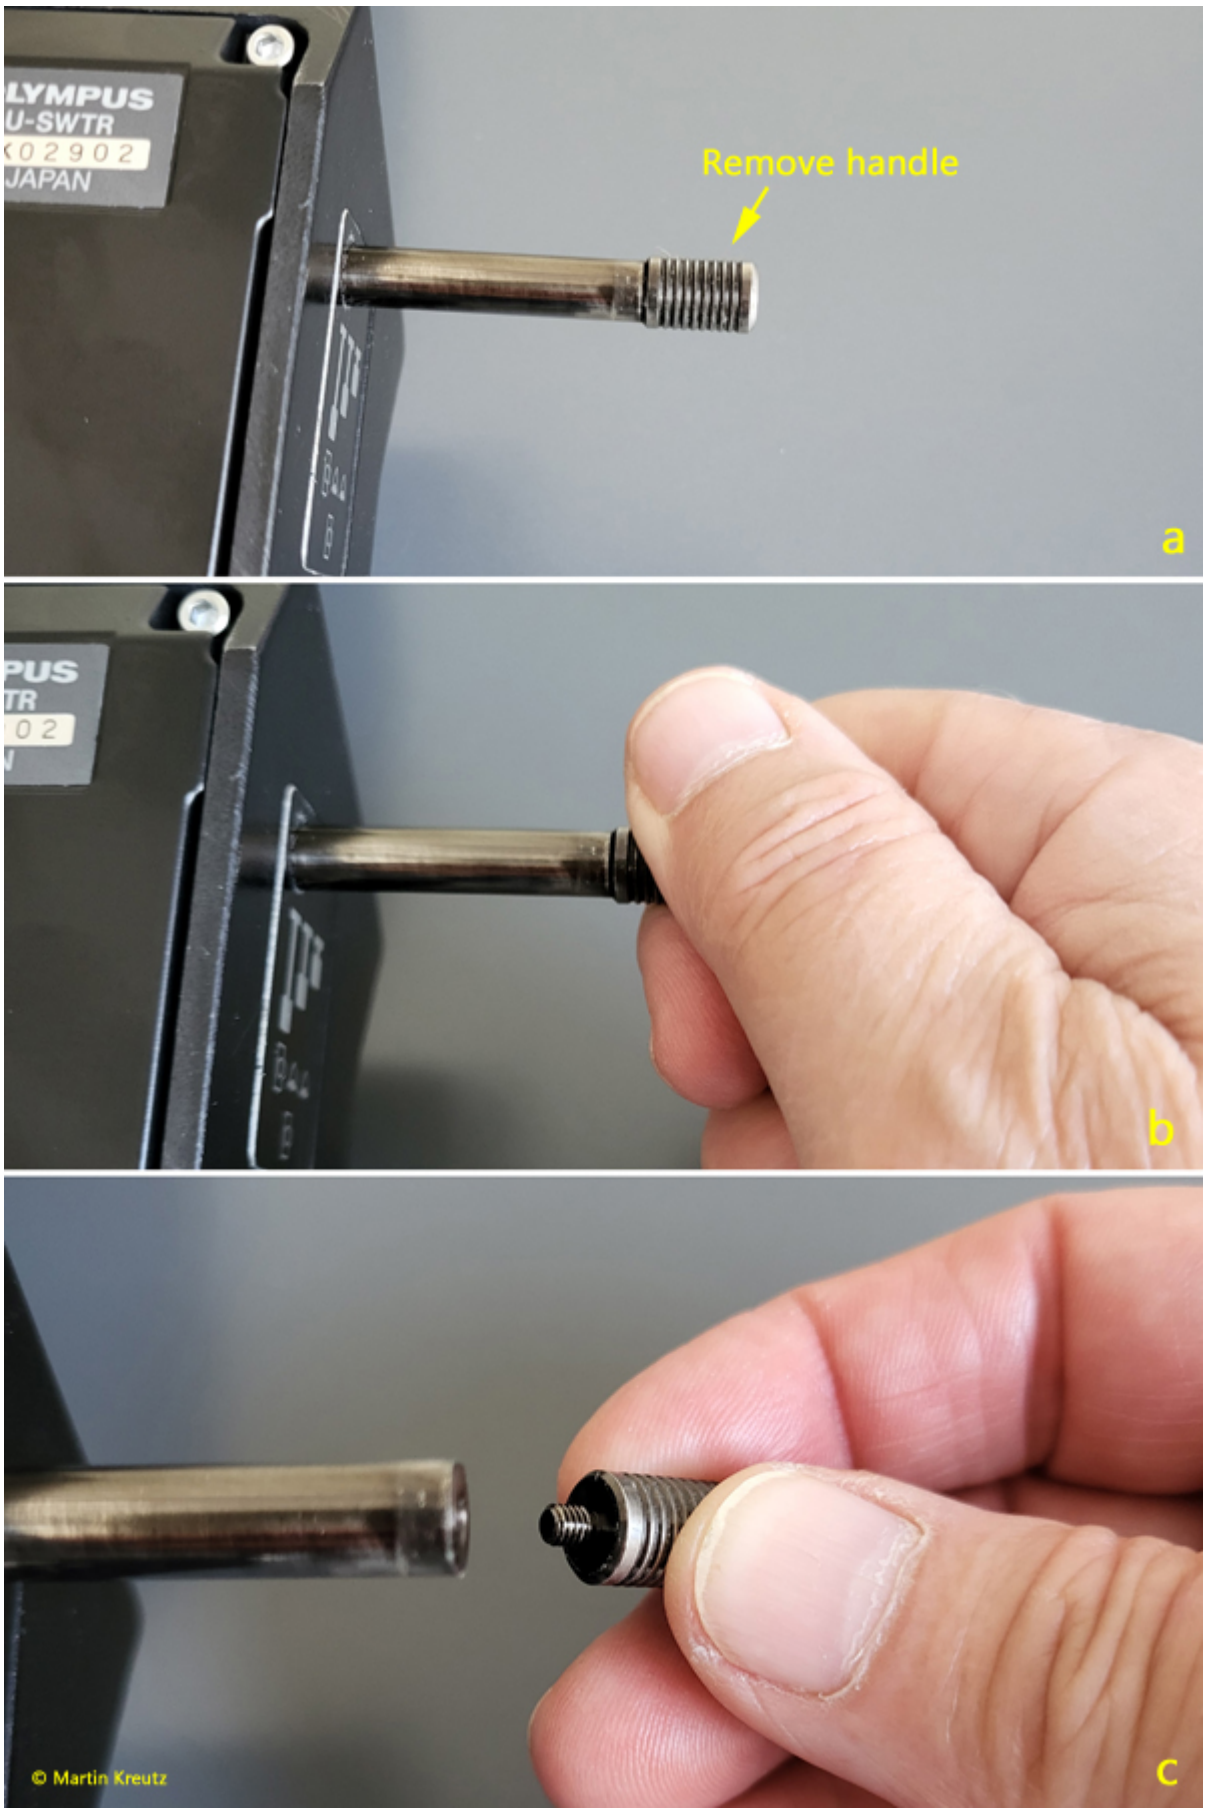
**Fig. 3 a-c:** Remove the handle from the push rod.

The handle must now be unscrewed from the side push rod (s. fig. 3 a-c).

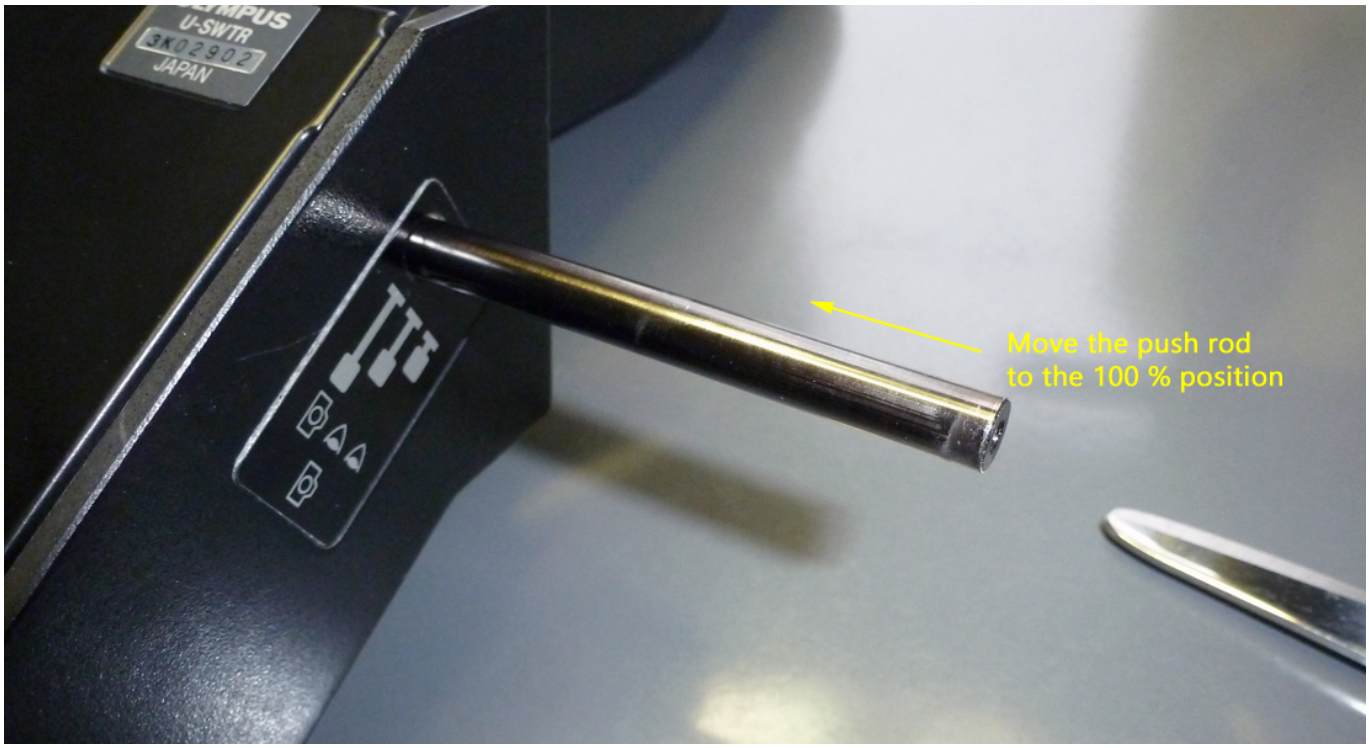
**Fig. 4:** Move the push rod to the 100% position.

The push rod is then pushed all the way in to the 100% position (s. fig. 4). This is the only way to guide it through the hole in the housing.

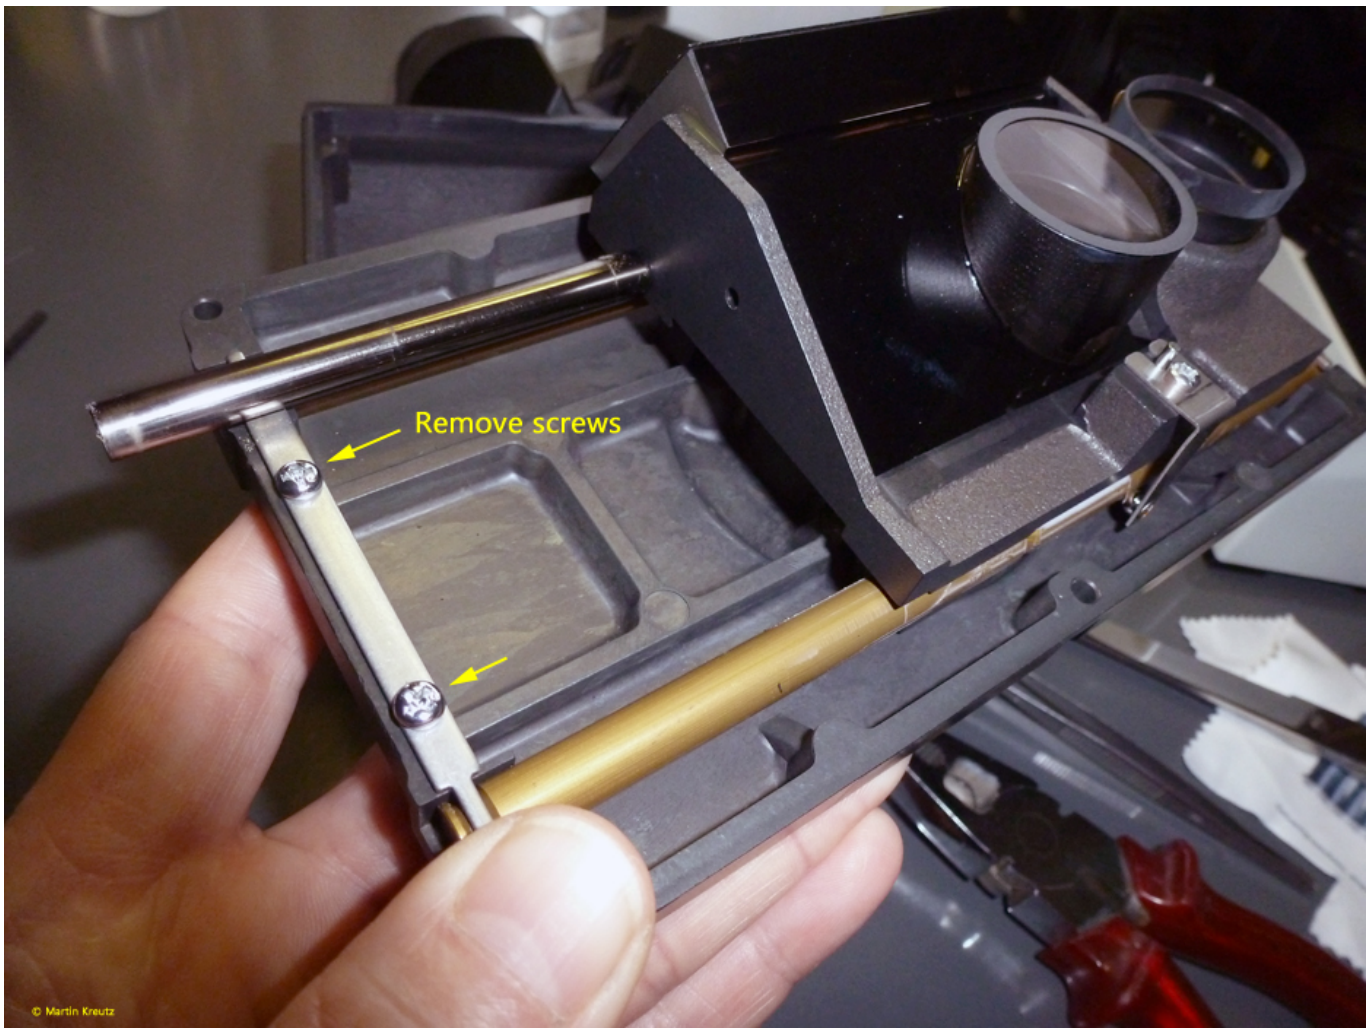
**Fig. 6:** Remove the screws of the fixing bracket on the left side.

The yellow anodized slide rails on which the beam splitter moves can be seen clearly. These must be taken out in order to completely remove the old grease. To do this, loosen the 4 screws with which two fixing brackets are screwed onto the base plate (s. fig. 6 and 7).

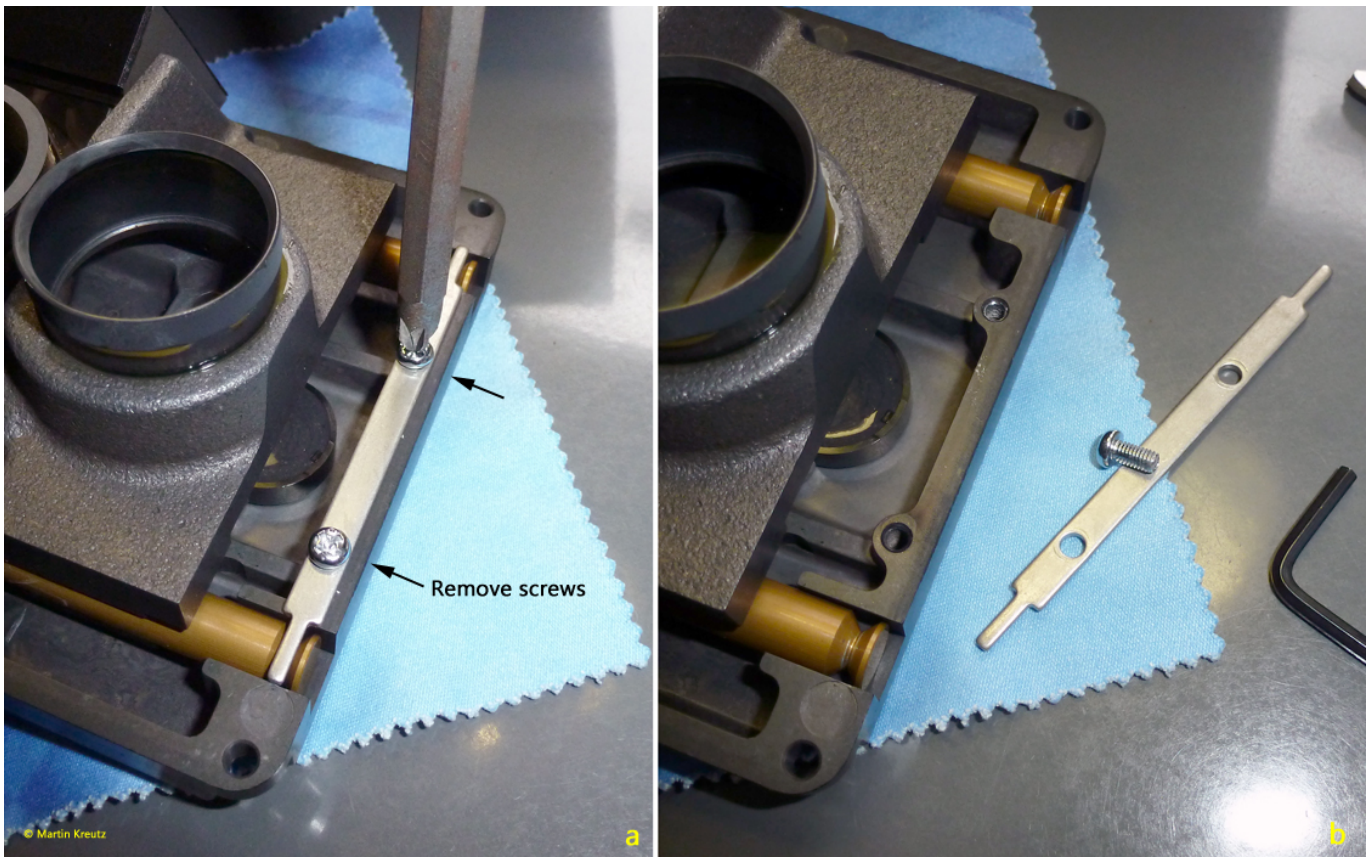
**Fig. 7:** Remove the screws of the fixing bracket on the rigth side.

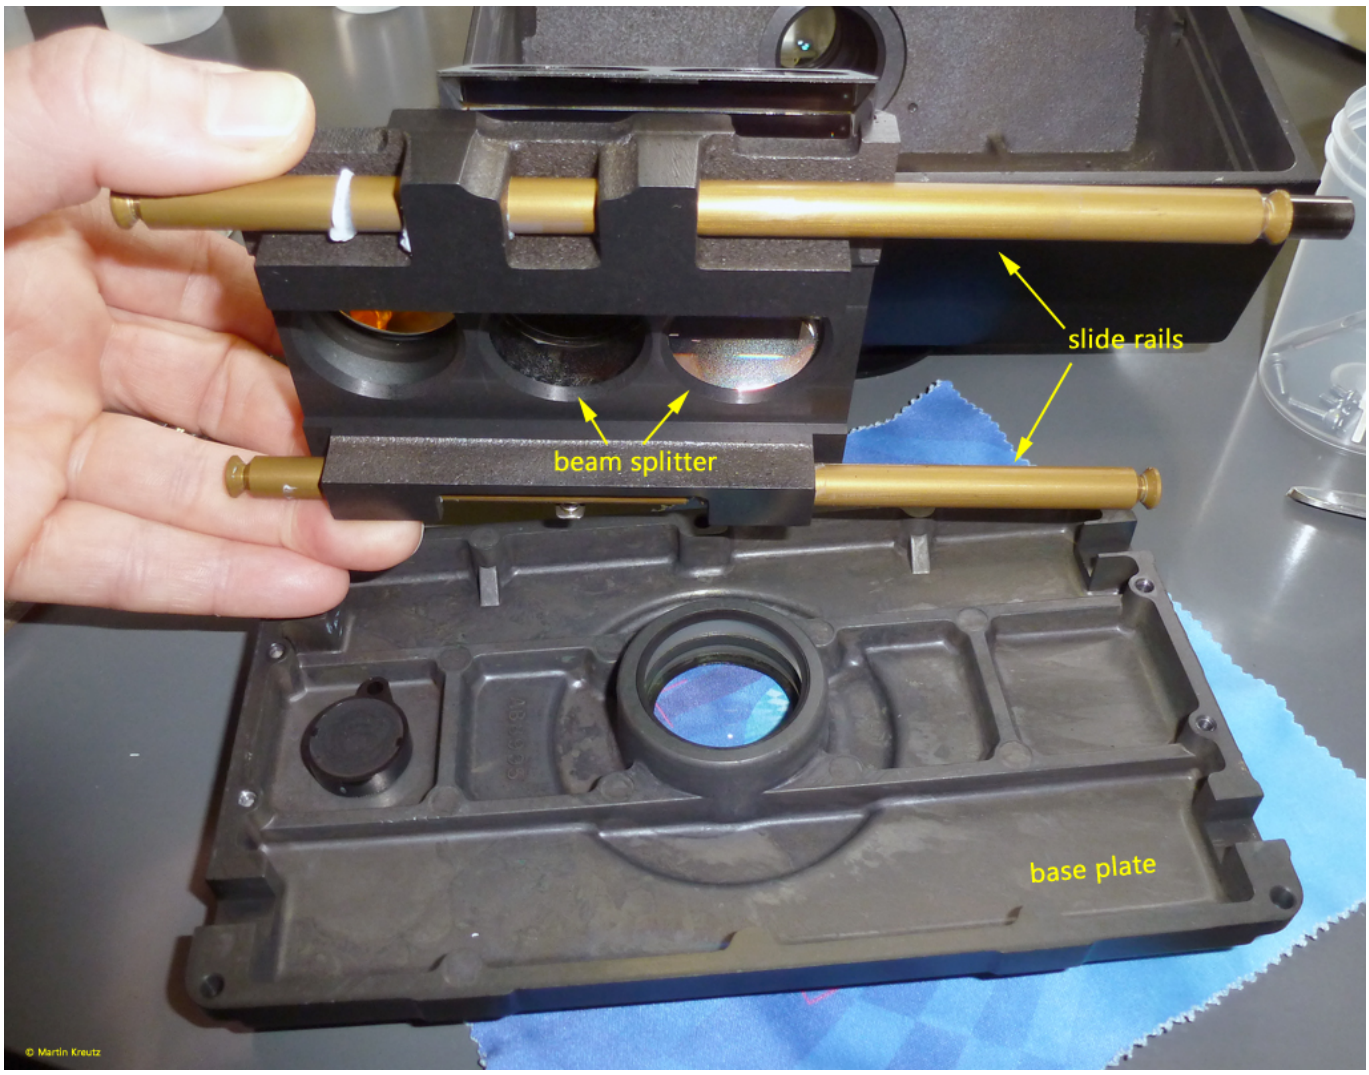
**Fig. 8:** The detached beam splitter from the base plate.

Now the beam splitter together with the slide rails can be detached from the base plate (s. fig. 8).

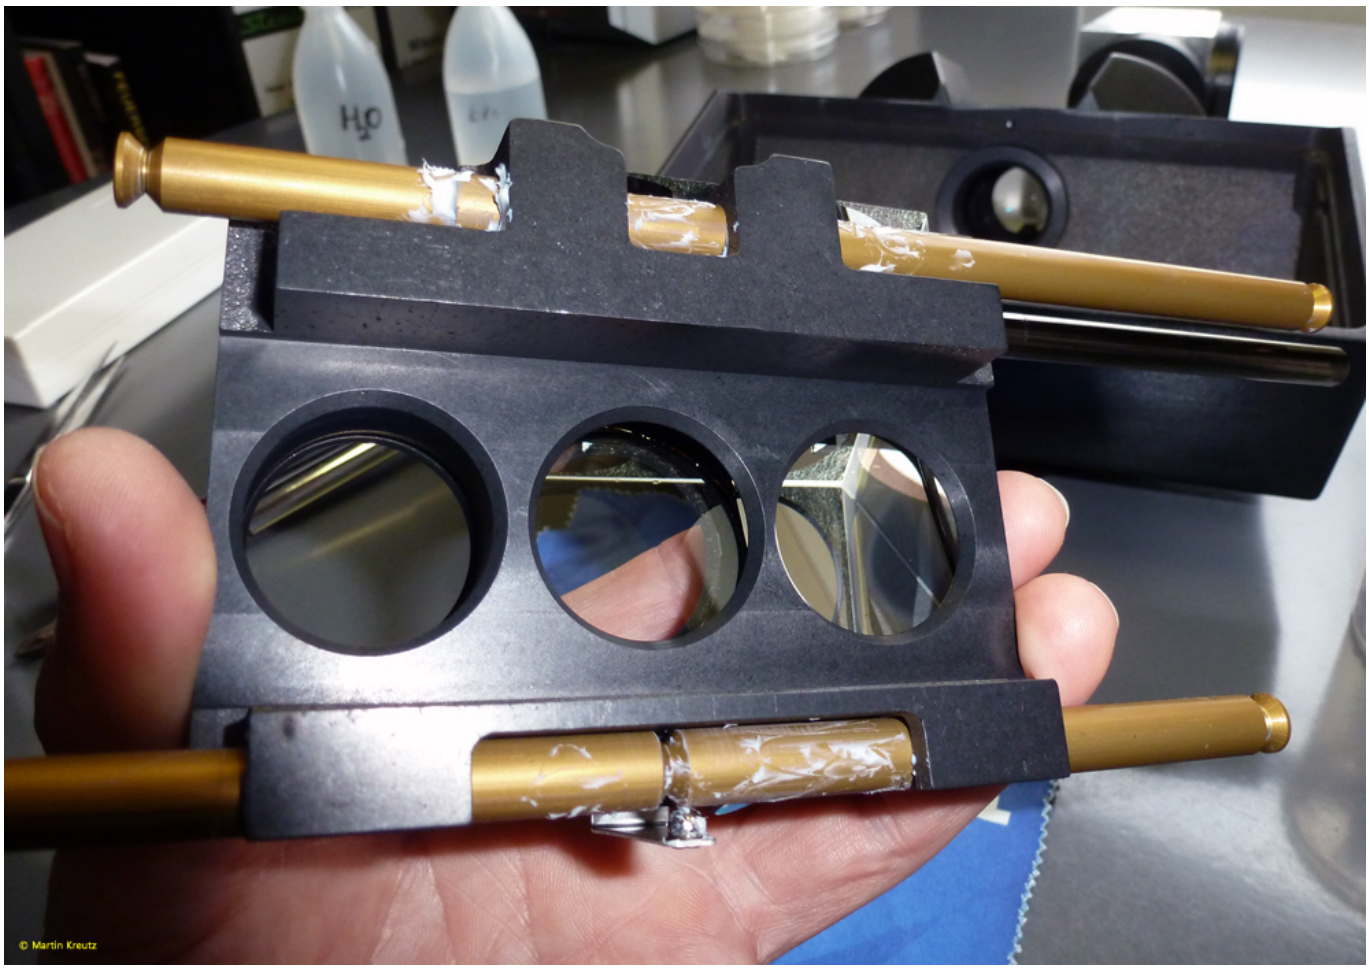
**Fig. 9:** The slide rails with new grease.

After removing it from the base plate, I thoroughly degreased the slide rails with isopropanol and then applied new grease with a toothpick (s. fig. 9). I used a perfluoropolyethers grease (PFPE) for the slide rails.
